Toshiba Satellite C55Dt-A5306 DC Power Jack Replacement

Replace DC power jack on Toshiba Satellite Laptop that is unable to conduct charge.

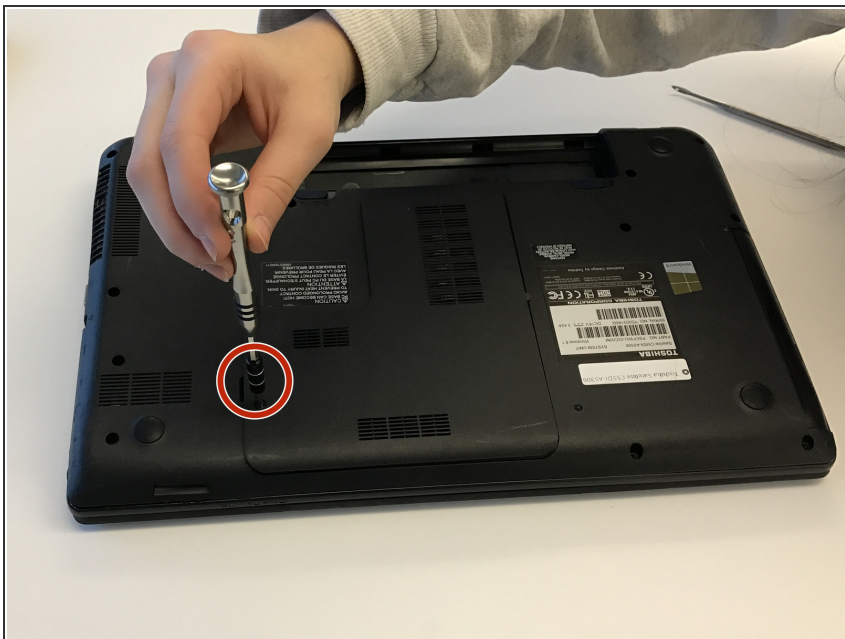
Step 1 — Back Cover

- Using the Phillips Head #0 Screwdriver, remove one 3mm Phillips #0 screw as indicated.

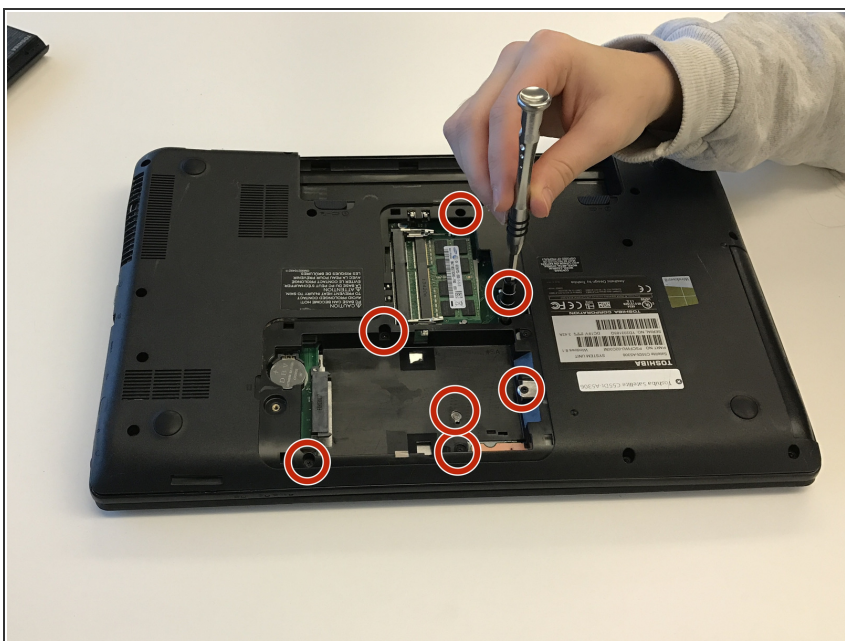
Step 2

- Remove hard drive cover. Using the Phillips Head #0 Screwdriver, remove seven 3mm Phillips #0 screws as indicated.

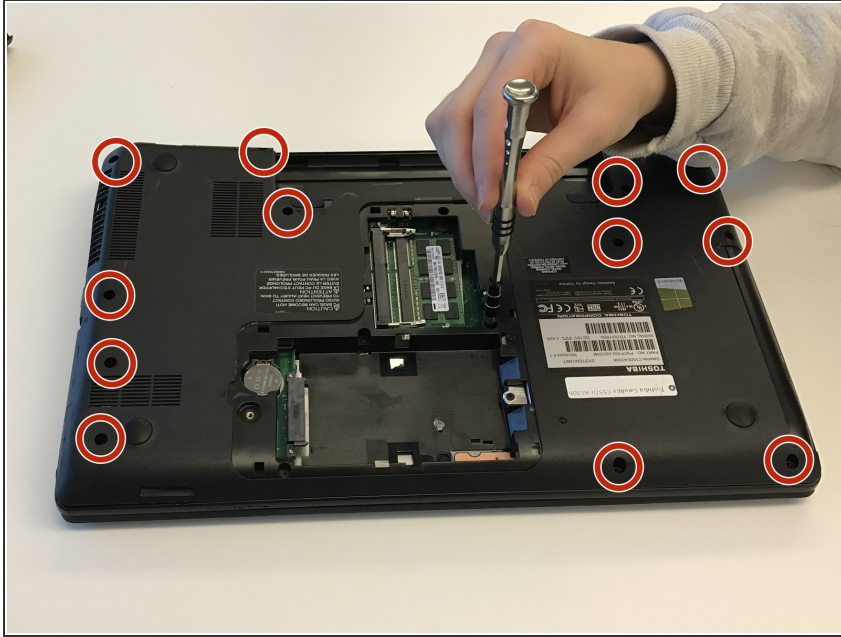
Step 3

- Using the Phillips Head #0 Screwdriver, remove twelve 3mm Phillips #0 screw as indicated.

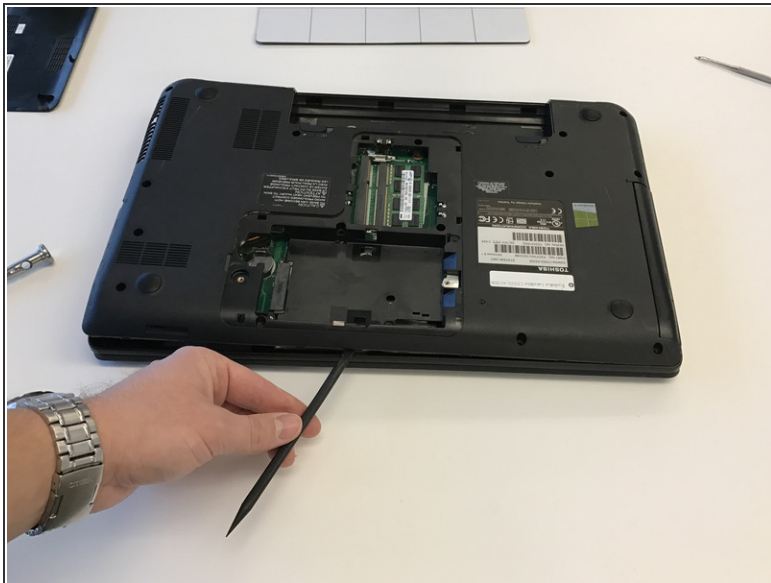
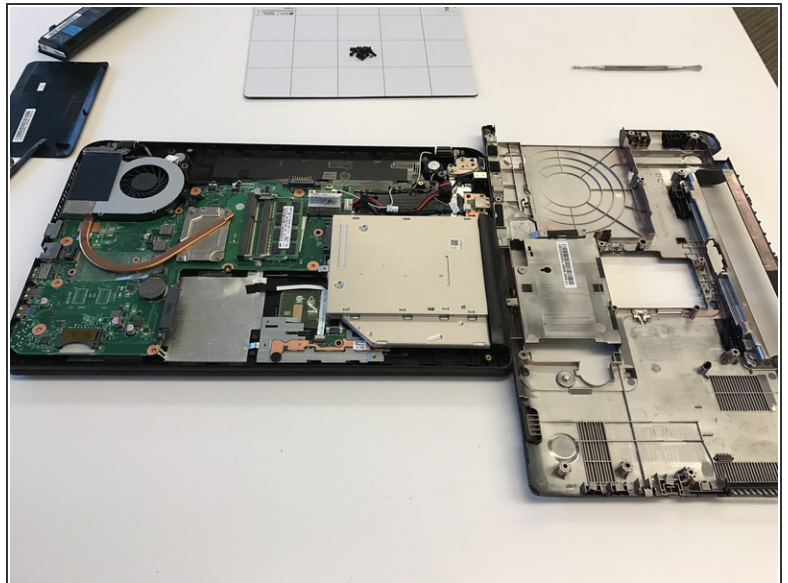
Step 4

- Using the plastic spudger, pry the back off along the periphery of the laptop.

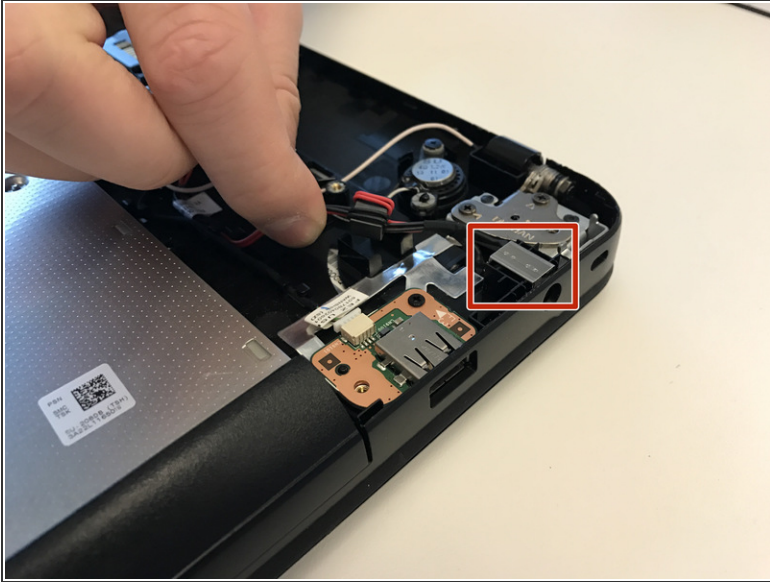
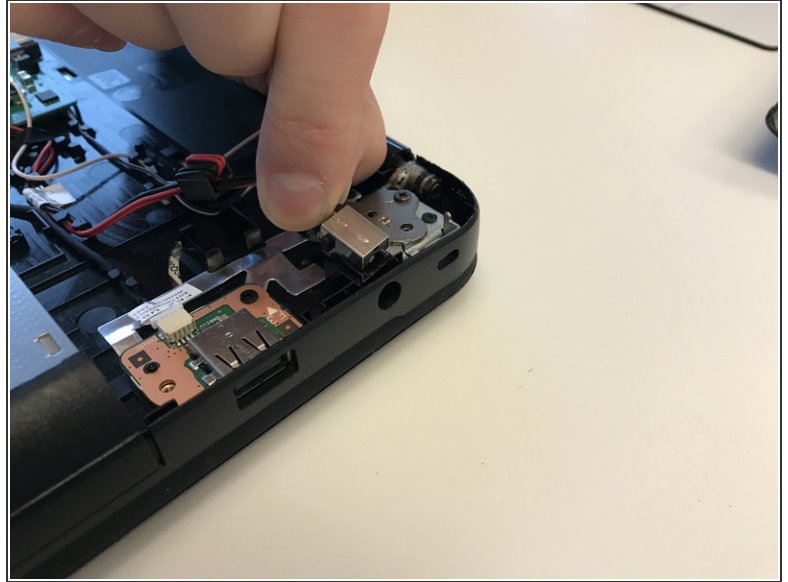
Step 5 — DC Power Jack

- Remove the DC power jack from its plastic retaining piece, just inside of the charger inlet.

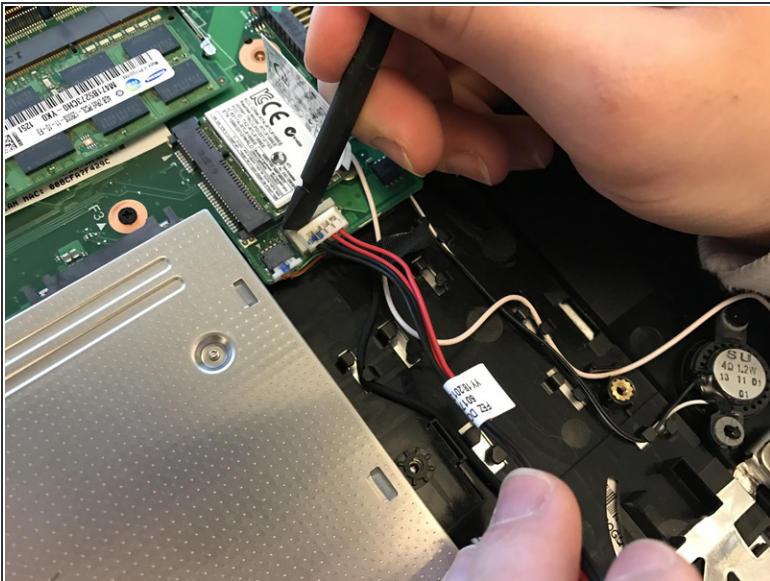
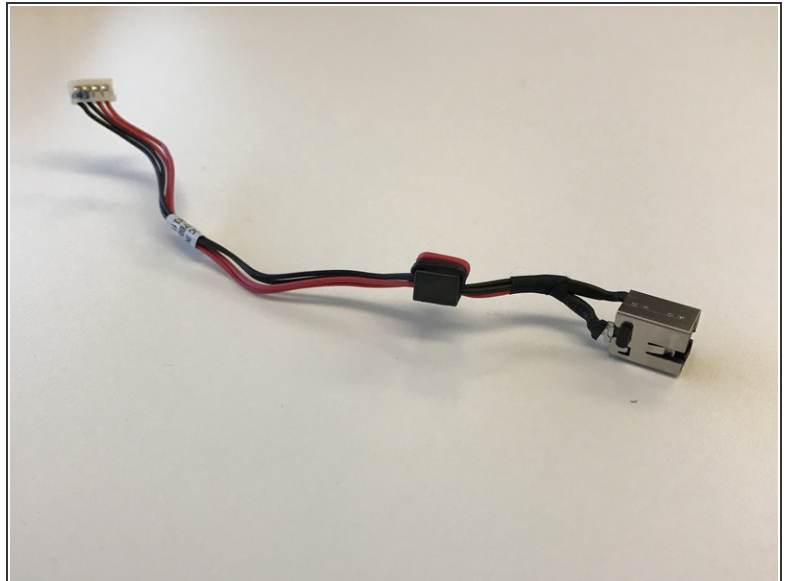
Step 6

- Use the nylon spudger to remove the connecting wires from the motherboard. Insert the spudger between the terminal plastic piece of the wire and its retaining clip on the motherboard. The wire should release without much force.
